California Department of Parks and Recreation  
Bidwell Mansion Post-Fire Assessment

December 22, 2025

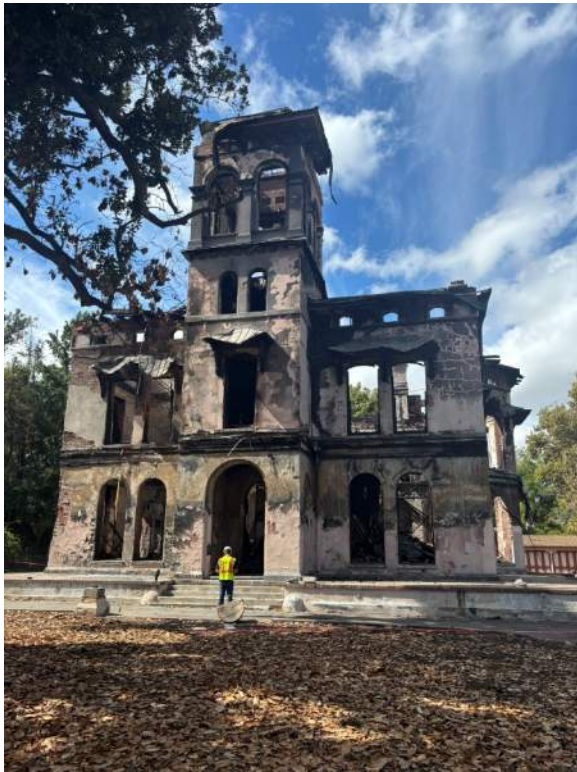
**01: Primary (east) elevation, 09.09.25.**

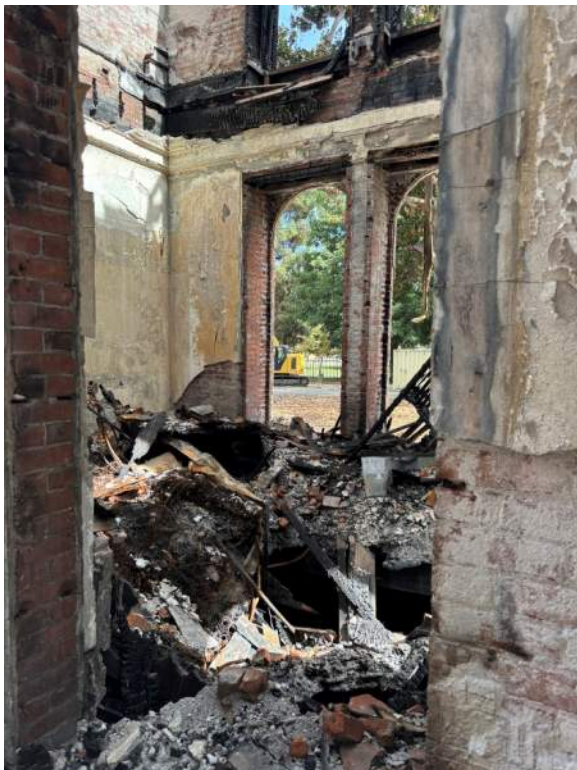
**08: Interior debris and conditions, 09.09.25.**

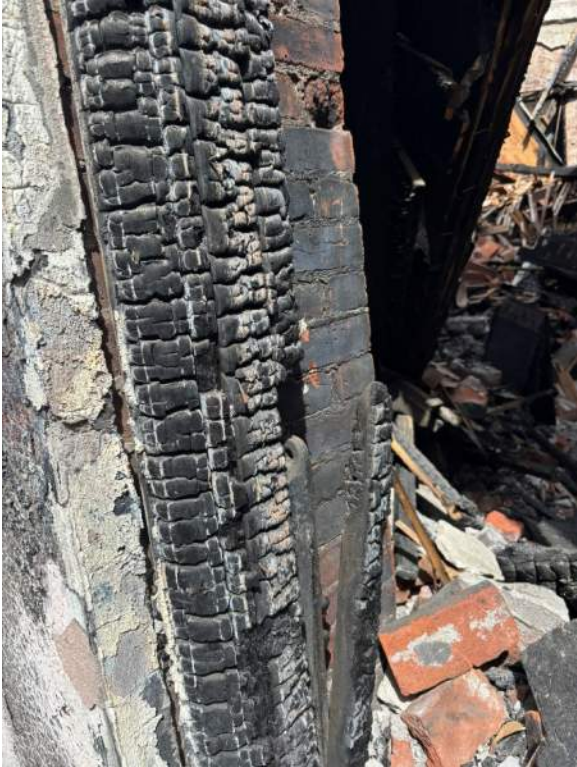
09: Typical window frame, 09.09.25.

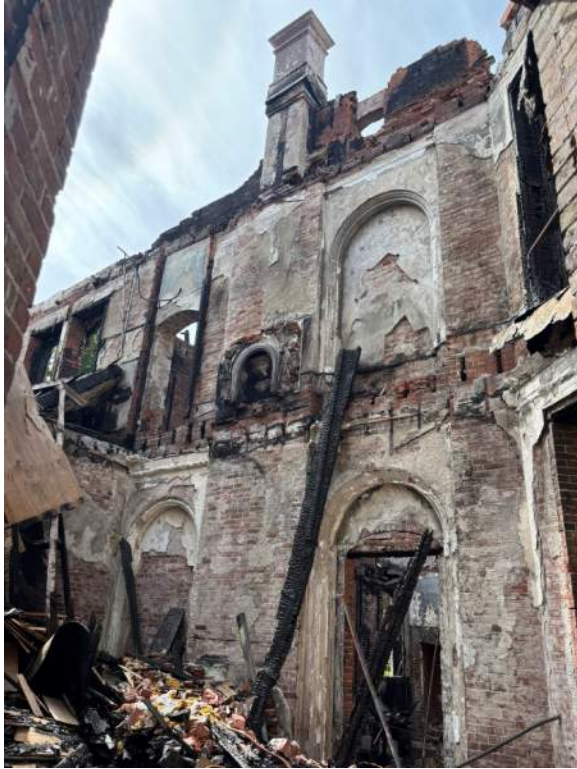
13: Building interior conditions- intact fireplace surround, 09.09.25.

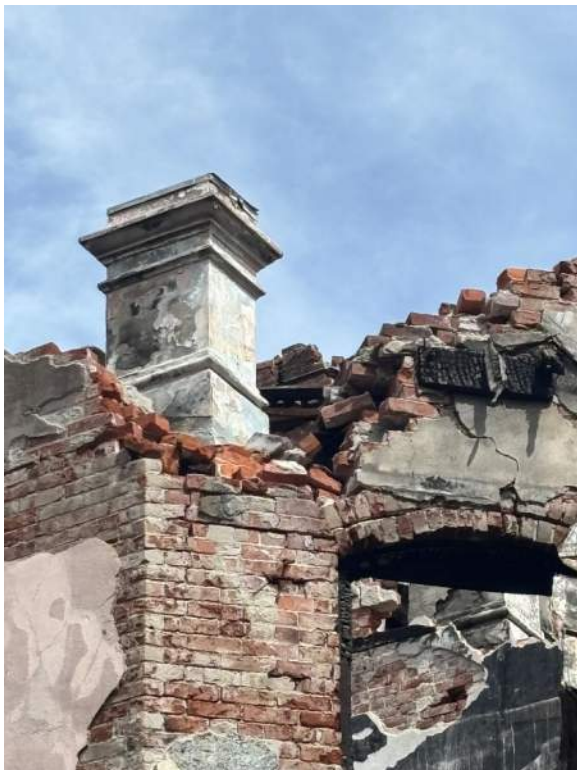
14: Exterior conditions- damaged brick, 09.09.25.

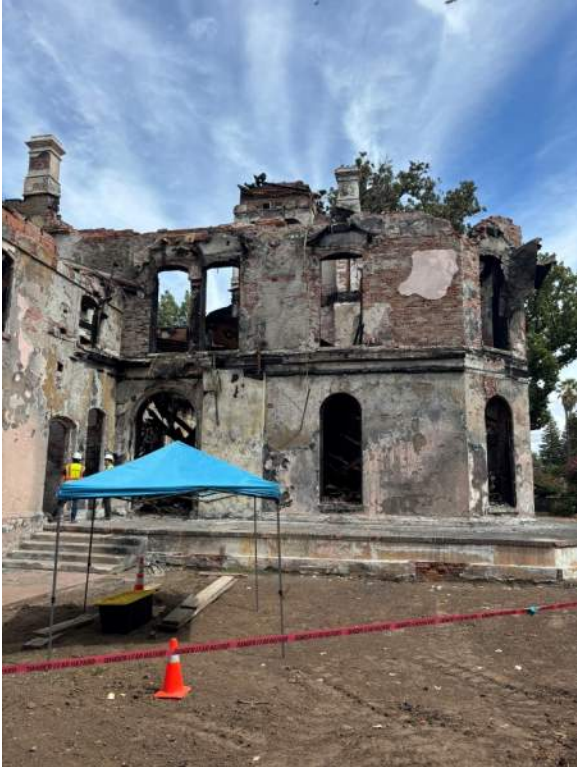
15: West elevation conditions, 09.09.25.

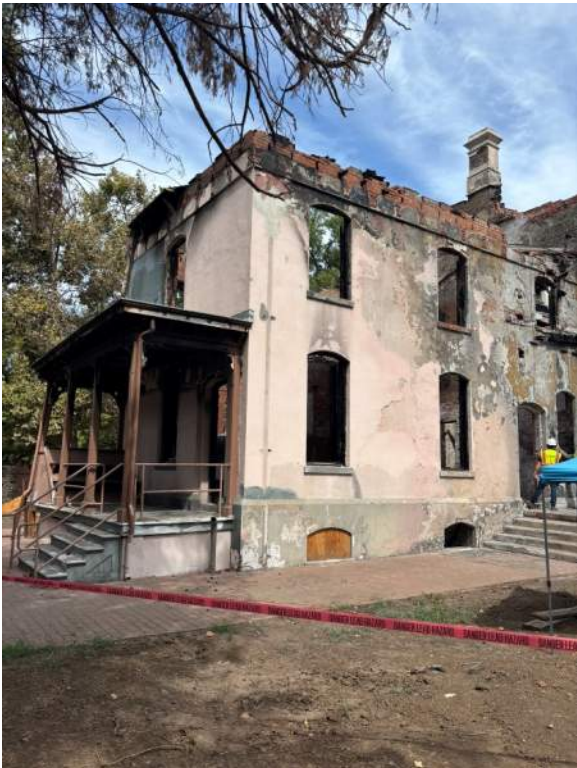
16: Kitchen and rear (west) porch, 09.09.25.

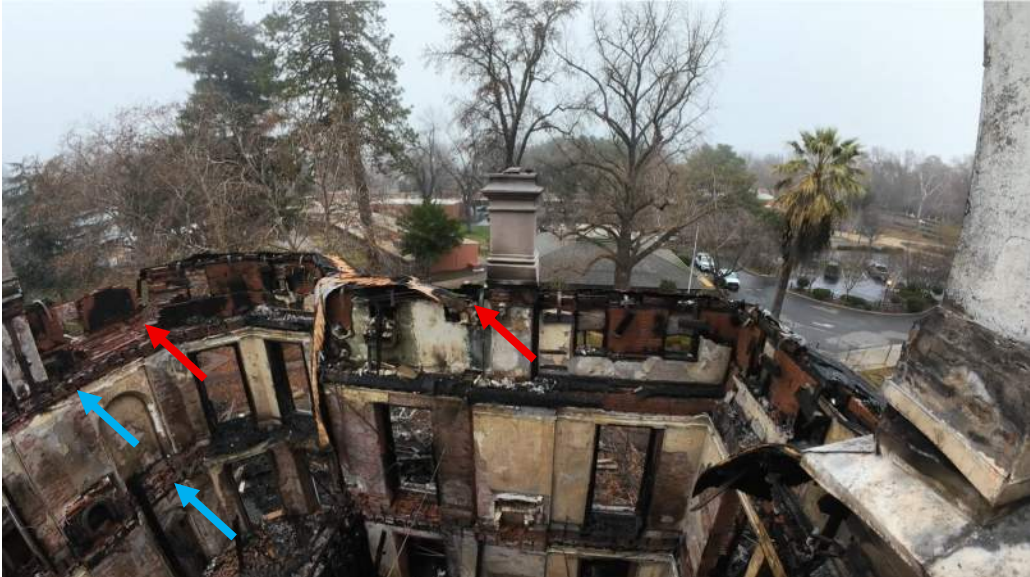
**19: Bidwell Mansion interior looking North towards the Visitor Center parking lot. Red arrows indicate sections of third story walls damaged by the collapsing roof. Blue arrows indicate where collapsing floors damaged the walls.**

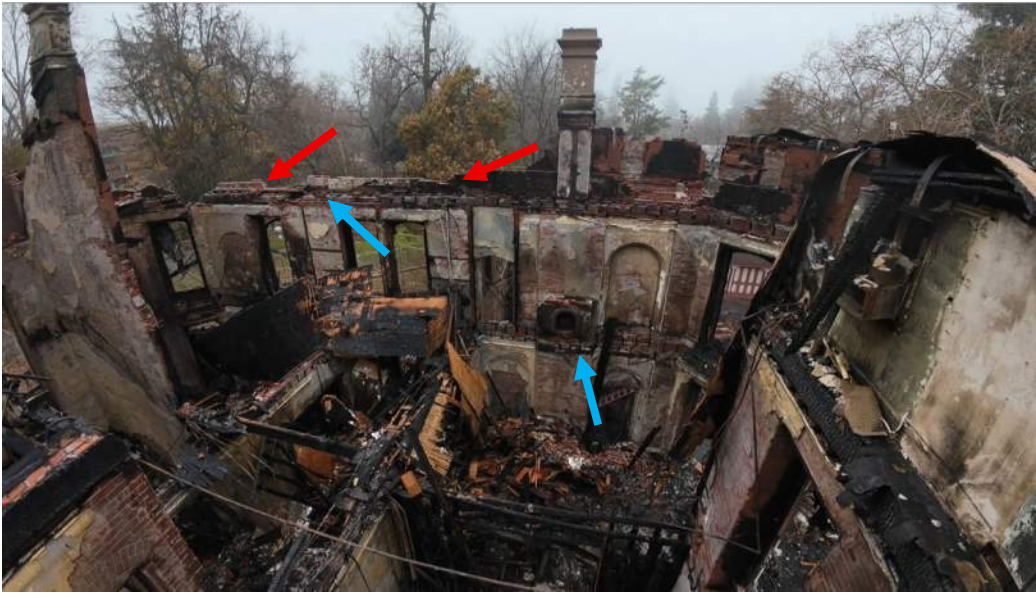
**20: Bidwell Mansion interior looking towards the Carriage House. Red arrows indicate sections of third story walls destroyed by the collapsing roof. Blue arrows indicate where collapsing floors damaged the walls.**

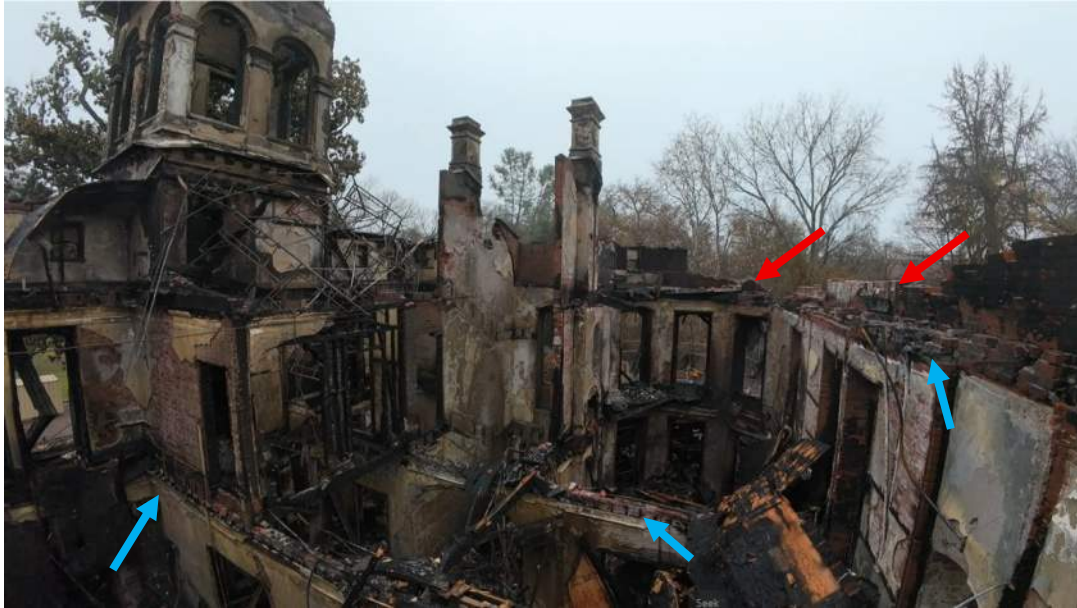
**21: Bidwell Mansion interior looking East. Red arrows indicate sections of third story walls destroyed by the collapsing roof. Blue arrows indicate where collapsing floors damaged the walls.**

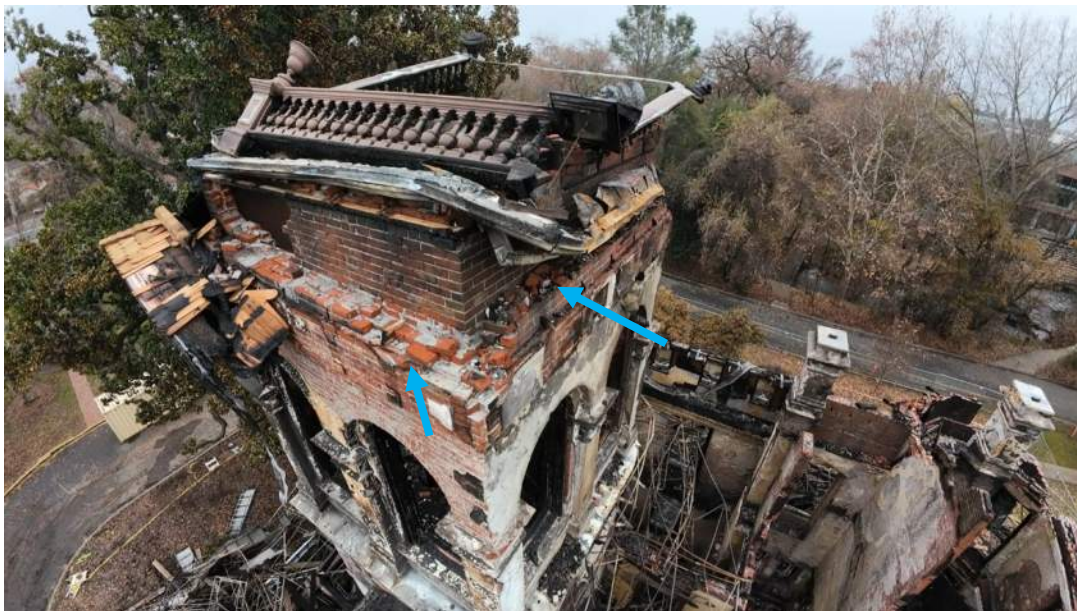
**22: Exterior aerial view of the Bidwell Mansion tower. Note the extensive damage that occurred to the brick, not only where the section of low wall collapsed, but also where attached wood materials damaged brick while collapsing (blue arrows).**

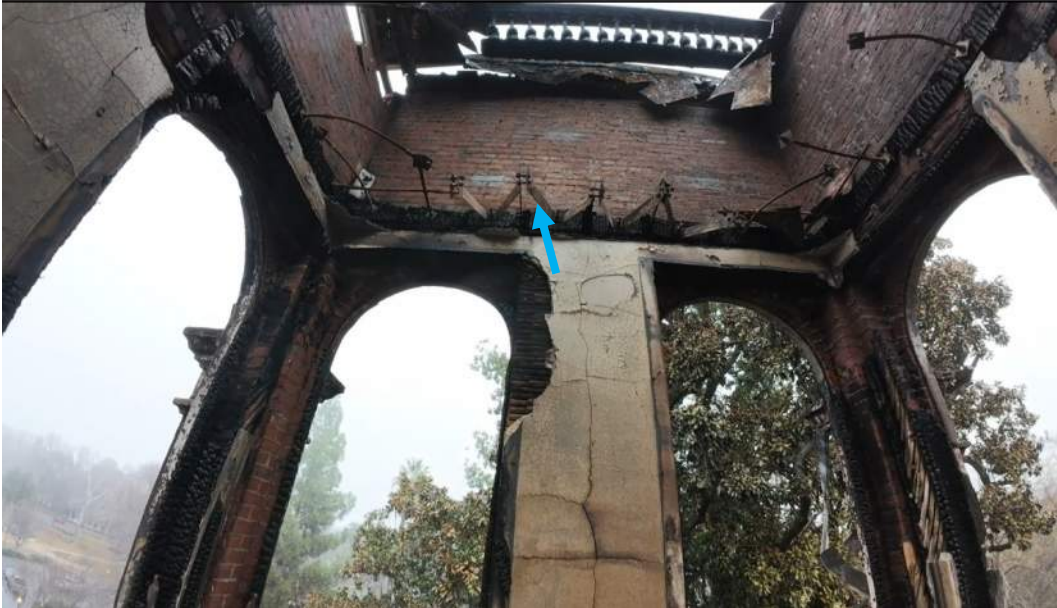
23: Bidwell Mansion tower seismic retrofit remains.

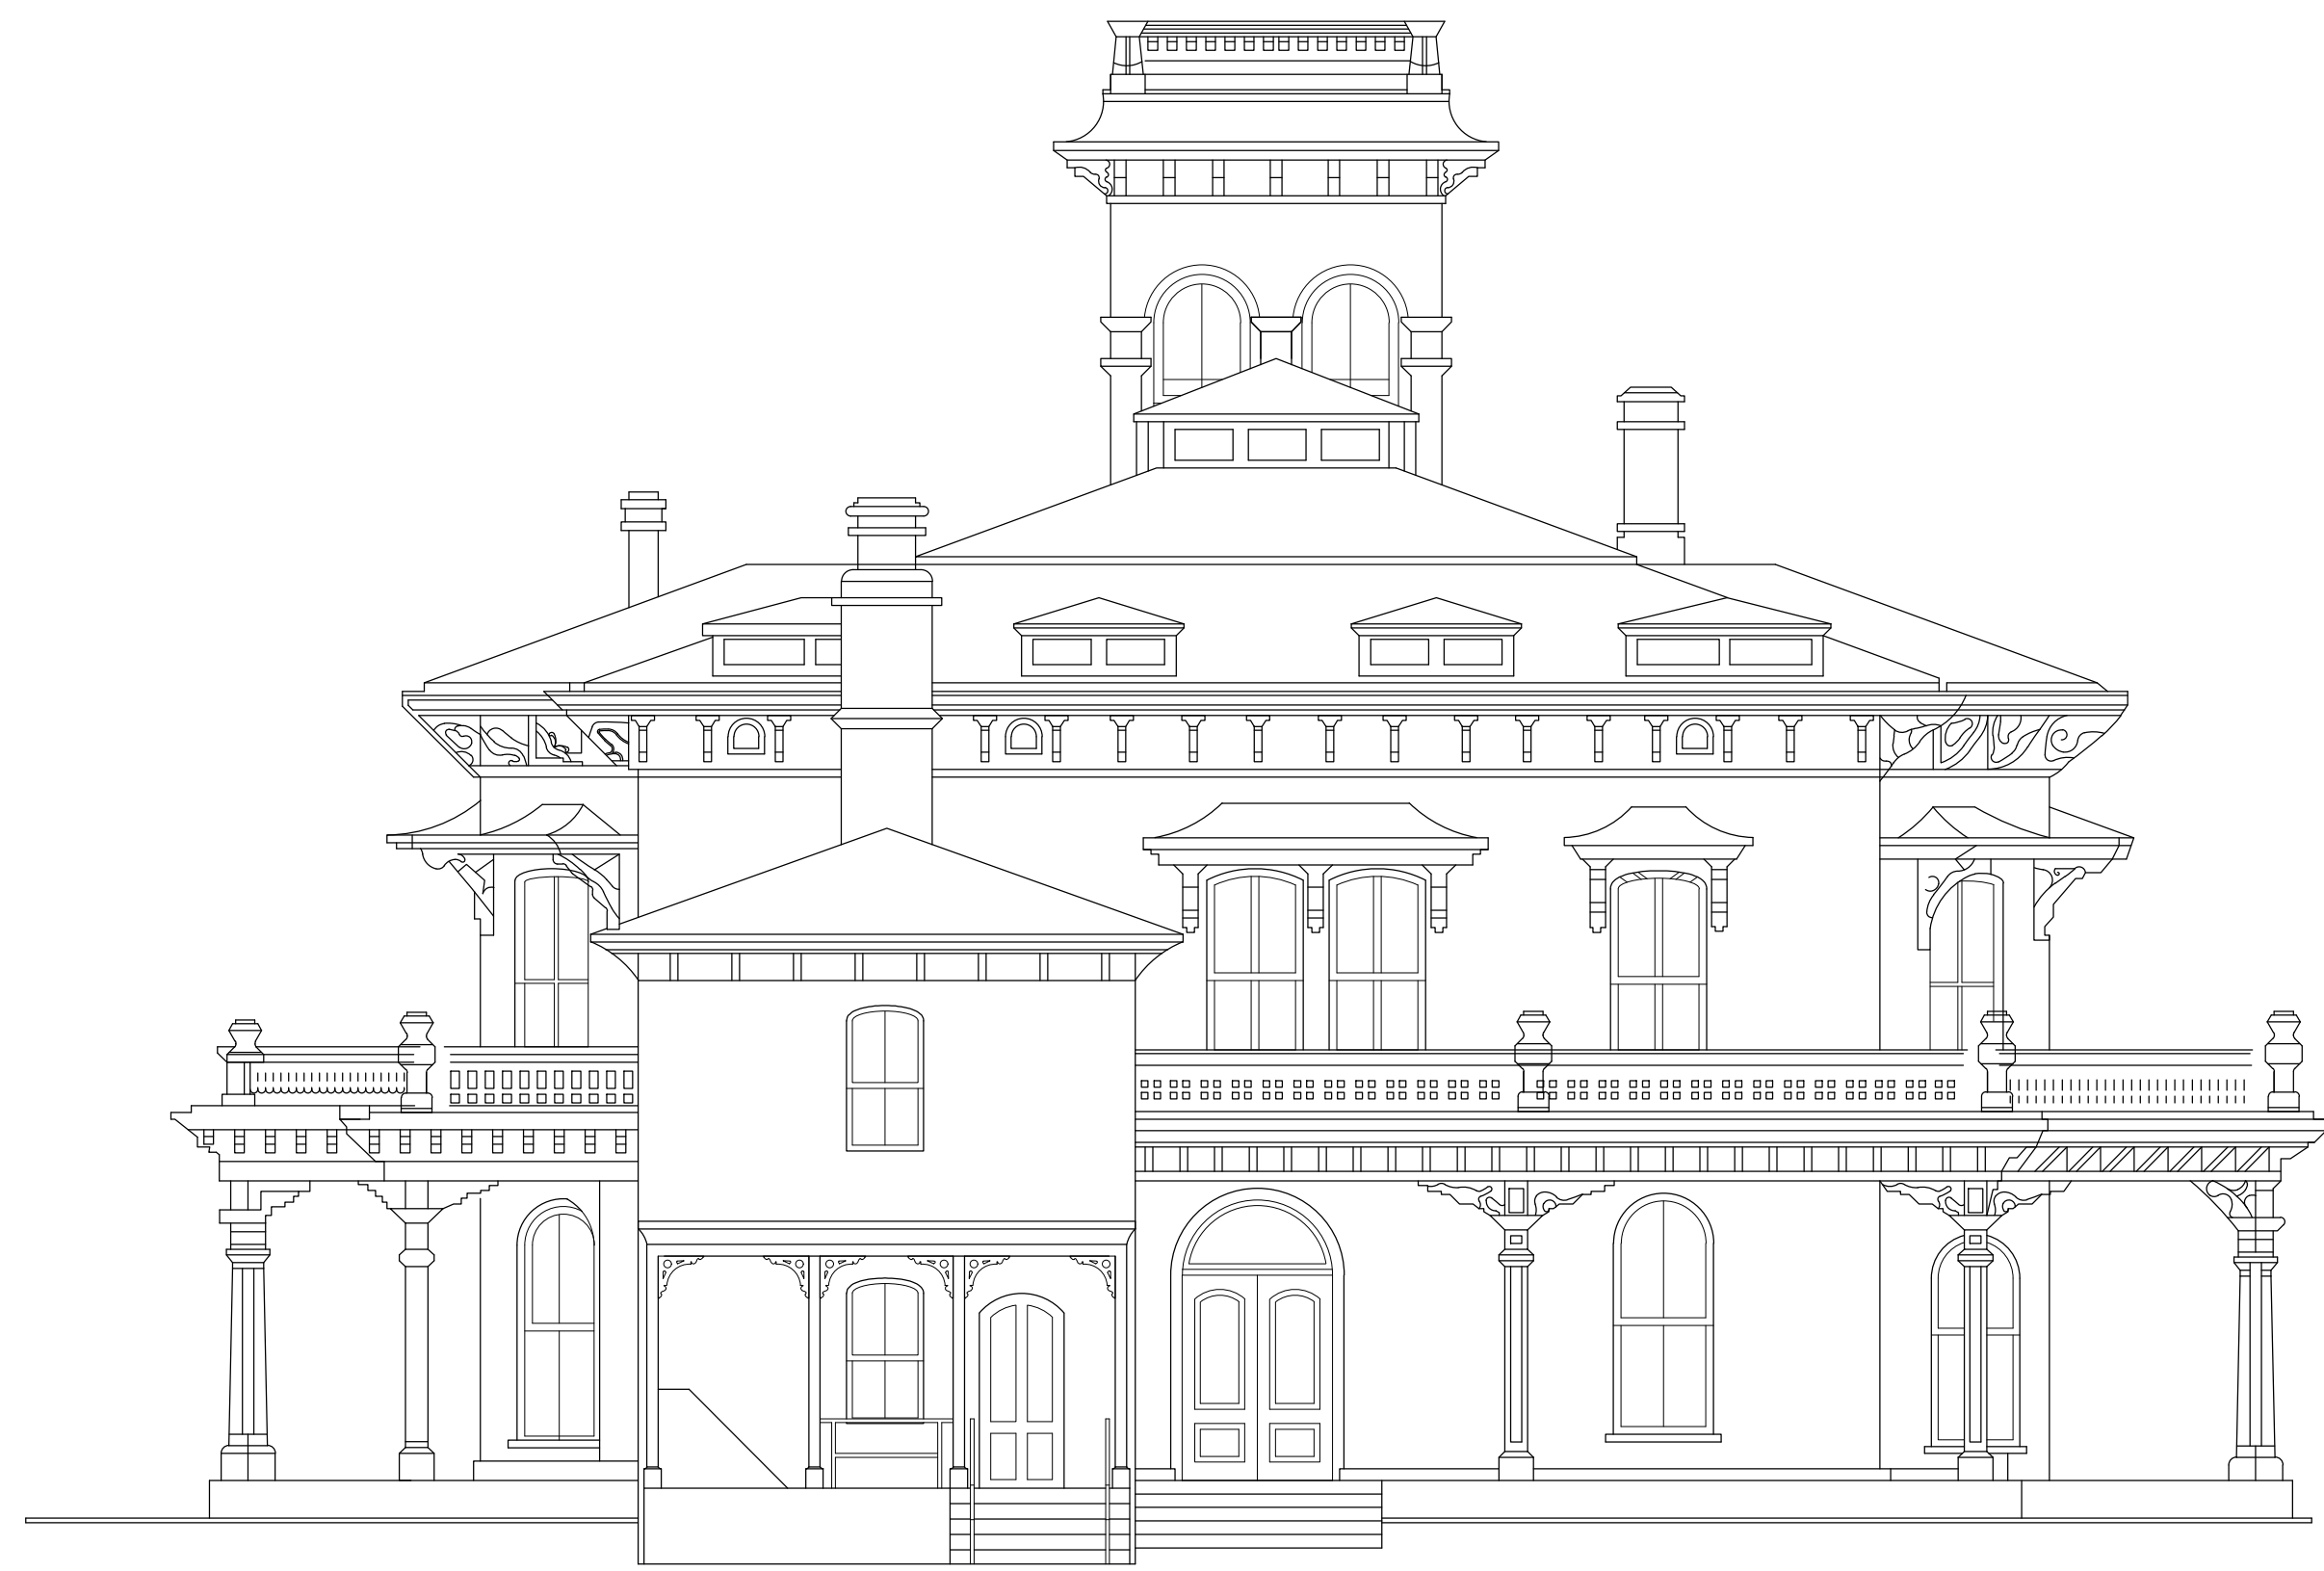
4 WEST ELEVATION  
SCALE@24X36 1/8" = 1'-0"
